**An Analytically Validated Highly
Damped Repair for Acoustically
- Induced Cracking on the F/A-18
Nacelle Skin**

DSTO-TR-1162

**Airframes and Engines Division
Aeronautical and Maritime Research Laboratory**

June 2001

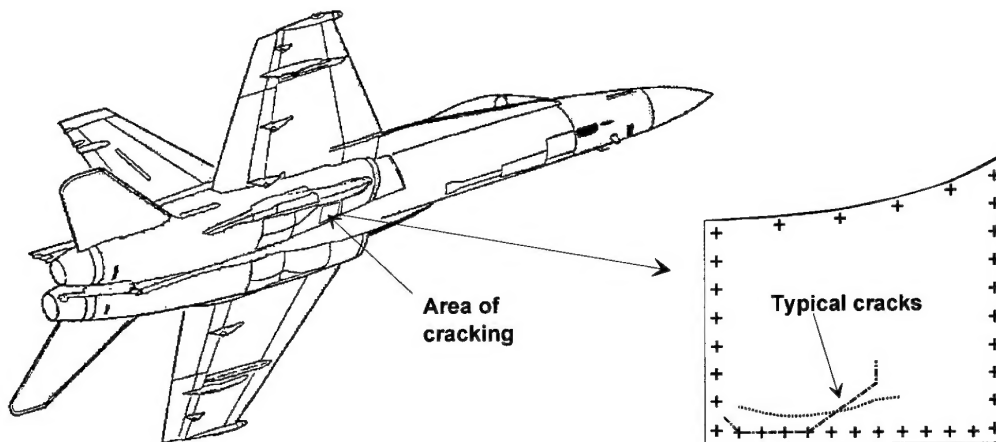
Figure 1 - Location of the cracking in the lower nacelle inlet.

The standard repair for such cracking is to remove and replace the panel. The standard long term fix is to incorporate additional stiffeners on the inside to stiffen the panel. This has two effects; firstly to reduce the panels response, i.e. lower stress for a given load and secondly it increases the resonant frequencies of the panel to frequencies well outside the recorded excitation frequencies.

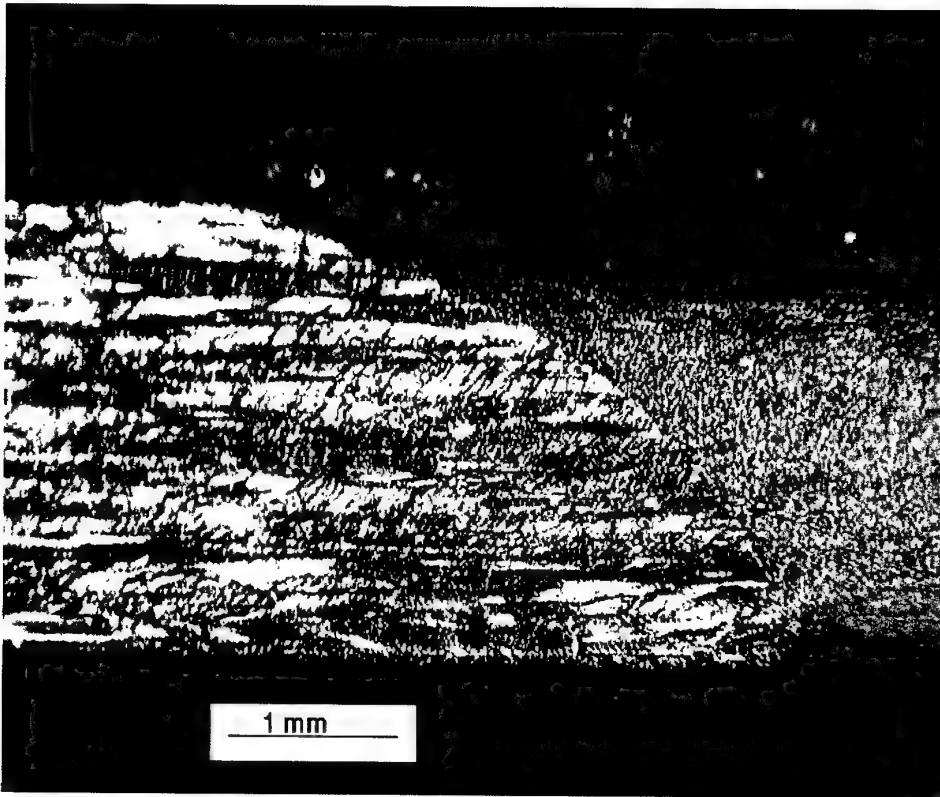
Figure 4. View of the tip of the crack in the thick end of the panel. The fatigue crack surface is the bright faceted region to the left and the deliberately broken surface is the mottled grey area to the right. Note the shape of the crack, much longer along the inside surface of the panel, indicating that a degree of bending was involved in the development of the crack. Also note that the fatigue crack surface is bright and highly detailed, and does not appear to have been rubbing [8].

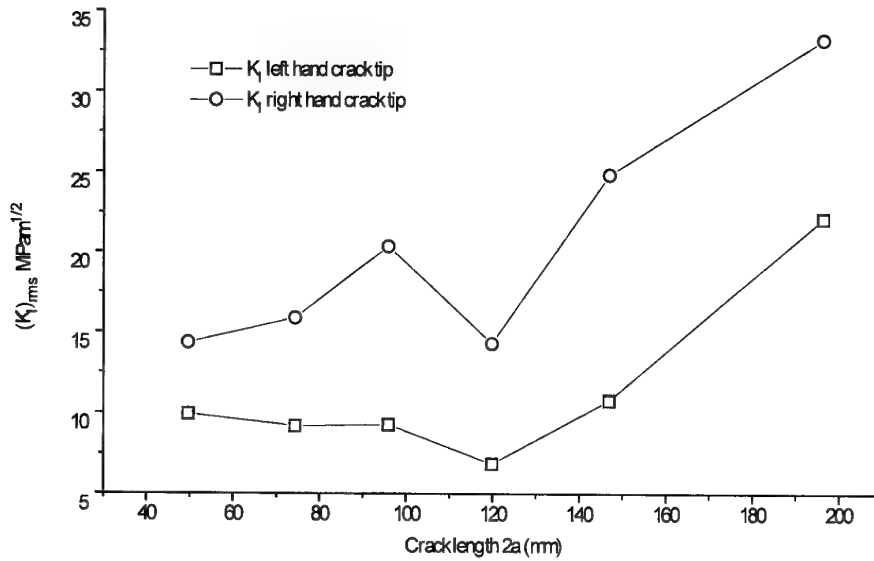
The rms mode I stress intensity factor $(K_I)_{rms}$ for the cracked un-repaired panel is shown in Fig. 18a. As expected, the general response is an increase of $(K_I)_{rms}$ with crack length. The

left hand crack tip is always closer to the clamped edge of the panel than the right hand crack tip, and since the bending stresses are a maximum midway along the boundary, the right hand tip gives the highest value of $(K_I)_{rms}$. The values of $(K_I)_{rms}$ in relation to the fracture toughness, are significant and explain crack growth. For crack growth, threshold values of $(K_I)_{rms}$ are shown in Fig. 31.

Figure 18 (a) Stress intensity factor $(K_I)_{rms}$ in un-repaired panel for left and right hand crack tips

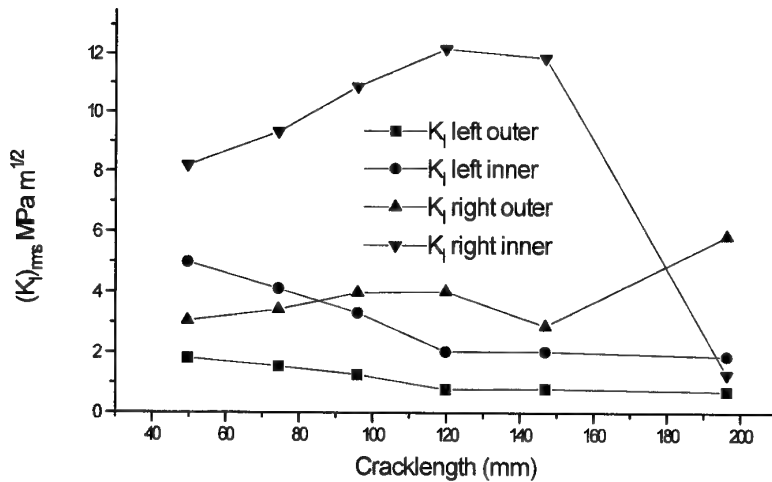
In the repaired panel the neutral axis is offset and as a result $(K_I)_{rms}$ is evaluated at both inner and outer surfaces of the skin; the repair being applied to the outer surface. Being a one sided repair the repair is more effective on the outer surface which is more closely restrained [6]. These bending effects are clearly shown in Fig. 18b. The right hand crack results in the highest values for $(K_I)_{rms}$ located on the inner surface. These values of $(K_I)_{rms}$ are significantly high before the crack grows out from under the patch and explain continued crack growth. For a normal 'static' repair in which the only significant events are manoeuvre and gust loads, the repair would be successful. However, in the acoustic excitation environment, the resonant frequency of the actual nacelle panel is of the order of 300-400Hz thus causing the repair to be ineffective.

Figure 18 (b) Stress intensity factor $(K_I)_{rms}$ in repaired panel. (Note the change in scale.) The rms mode II stress intensity factor, $(K_{II})_{rms}$ for the cracked un-repaired panel is shown in Fig. 19a. Little through thickness variation of $(K_{II})_{rms}$ has been found, hence values are only

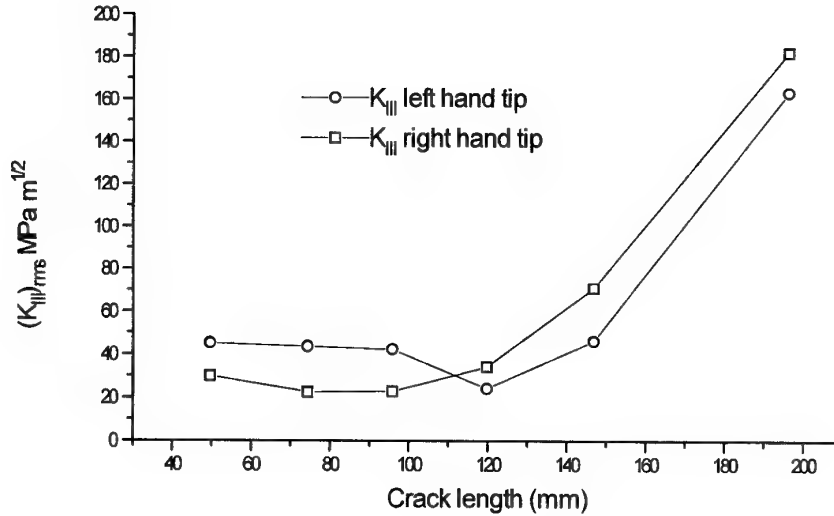
Figure 20 (a) Stress intensity factor $(K_{III})_{rms}$ for un-repaired panel.

The rms of mode III stress intensity factor $(K_{III})_{rms}$ for the cracked un-repaired panel is shown in Fig. 20a. The values of $(K_{III})_{rms}$ increase significantly with crack length for both left and right hand crack tips, and the numerical value of $(K_{III})_{rms}$ is greater than $(K_I)_{rms}$. Clearly $(K_{III})_{rms}$ will contribute significantly to crack growth. In the case of the repaired panel, shown in Fig. 20b, the values of $(K_{III})_{rms}$ for a crack tip under the patch are low, but not zero. However, once the crack grows outside the patch (i.e. for crack lengths > 120 mm) $(K_{III})_{rms}$ increases significantly.
